**DEPARTMENT OF TRANSPORTATION**

Quality Assurance and Source Inspection

Contract #: 04-0120F4Cty: SF/ALA Rte: 80 PM: 13.2/13.9File #: 69.28**WELDING INSPECTION REPORT****Resident Engineer:** Pursell, Gary**Address:** 333 Burma Road**City:** Oakland, CA 94607**Report No:** WIR-016516**Date Inspected:** 25-Aug-2010**Project Name:** SAS Superstructure**OSM Arrival Time:** 700**Prime Contractor:** American Bridge/Fluor Enterprises, a JV**OSM Departure Time:** 1900**Contractor:** Zhenhua Port Machinery Company, Ltd (ZPMC), Changxing Island **Location:** Shanghai, China**CWI Name:** Xu Le Feng**CWI Present:** Yes No**Inspected CWI report:** Yes No N/A**Rod Oven in Use:** Yes No N/A**Electrode to specification:** Yes No N/A**Weld Procedures Followed:** Yes No N/A**Qualified Welders:** Yes No N/A**Verified Joint Fit-up:** Yes No N/A**Approved Drawings:** Yes No N/A**Approved WPS:** Yes No N/A**Delayed / Cancelled:** Yes No N/A**Bridge No:** 34-0006**Component:** Tower & OBG Components**Summary of Items Observed:**

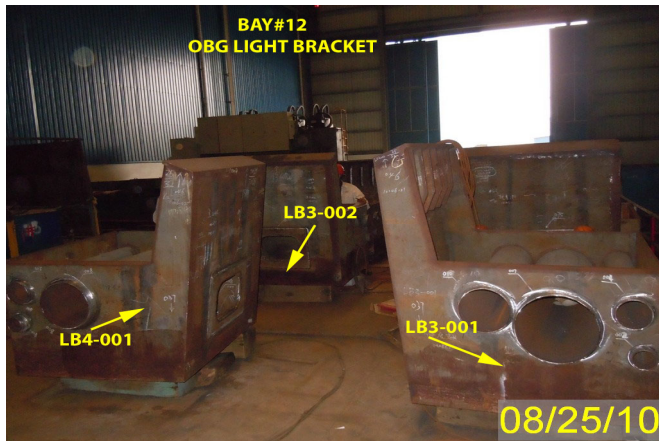
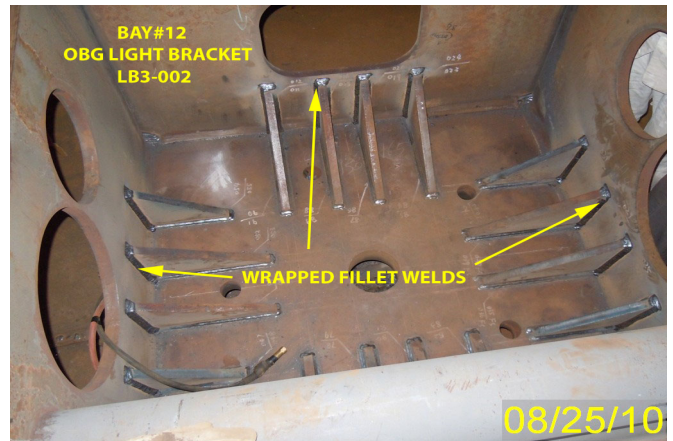
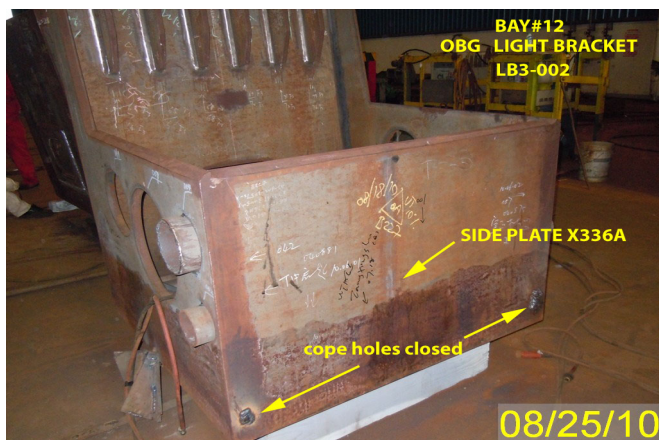
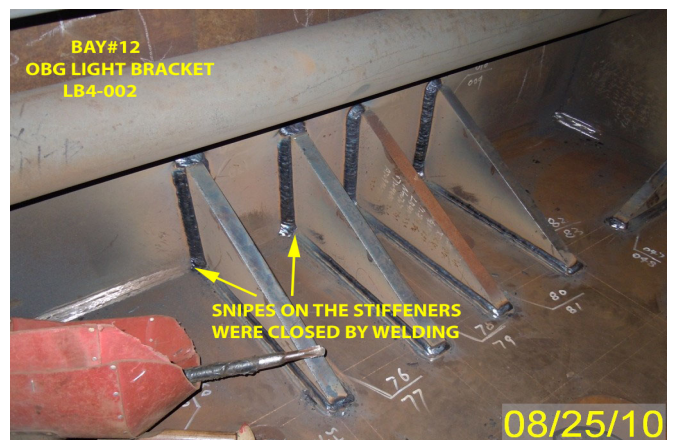
During the Caltrans Quality Assurance (QA) in-process observations of the fabrication of Light Bracket, this QA Inspector discovered the following issues:

- Wrapped fillet welds around the ends of the gussets inside 6 Light Brackets.

- Stiffeners' snipes were closed by welding.

- Side Plates (X336A and X336B) were fabricated with copes not shown in the approved shop drawings.

Subsequently, new welds were introduced to weld the copes.
